Manhole Inspection Summary

Manhole # S45C__099MH

Insp Date: **8/15/08 8:25 AM**

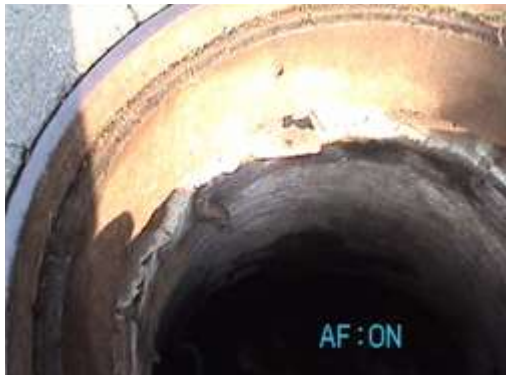
Defect 2

☒ **Leaks**

Frame leaks

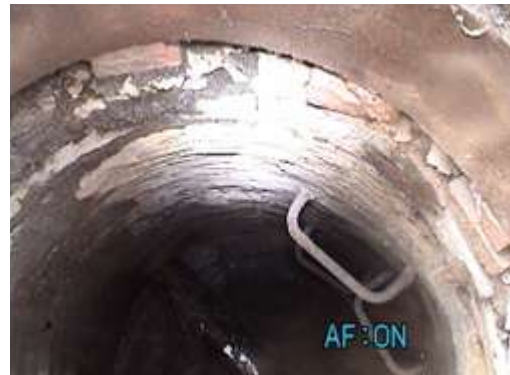
Defect 1

Condition: ☐ Sound ☐ Cracked ☐ Root Intrusion ☒ **Loose Brick** ☐ Deteriorated

Infiltration: ☐ None ☐ Joint ☐ Cracks ☒ **Mortar** ☐ Roots ☐ Wall

Loose brick

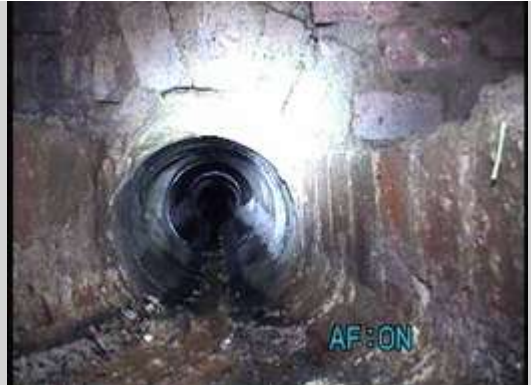
12 O'Clock Outflow

8 in. Circular Gravity Sewer
Pipe Out @ 12 O'Clock

Pipe Height: **8.4** (in.) Rod and Bar (Angled)
Pipe Material: **Clay** ☐ Pipe Lined
Invert Depth: **10.05** (ft.) Flow Characteristics: **Slow**
Deposits: ☒ None ☐ Mud ☐ Sludge ☐ Debris ☐ Grease
Silt Depth: (in.) Deposits Extent:
Infiltration: **None** Pipe Seal Cond: **Sound**

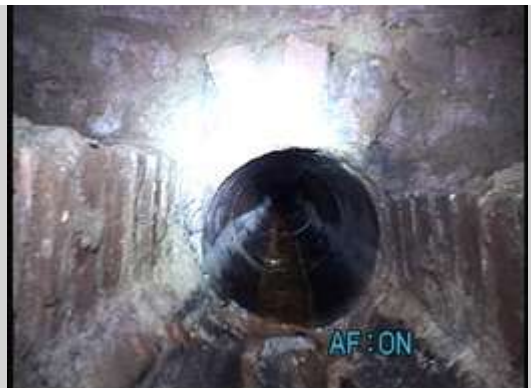
6 O'Clock Inflow

8 in. Circular Gravity Sewer
Pipe In @ 6 O'Clock

Pipe Height: **8.4** (in.) Rod and Bar (Angled)
Pipe Material: **Clay** ☐ Pipe Lined
Invert Depth: **9.90** (ft.) Flow Characteristics: **Slow**
Deposits: ☒ None ☐ Mud ☐ Sludge ☐ Debris ☐ Grease
Silt Depth: (in.) Deposits Extent:
Infiltration: **None** Pipe Seal Cond: **Sound**

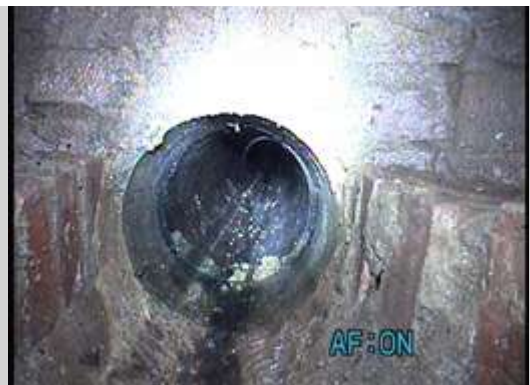
9 O'Clock Inflow

8 in. Circular Gravity Sewer
Pipe In @ 9 O'Clock

Infiltration: **None**

Pipe Seal Cond: **Sound**
